Coating Cuts Galling When Stamping HSLA Parts

A new tool coating eliminates severe galling when deep drawing brackets for automotive seating assemblies, and slashes downtime needed for part rework and die maintenance.

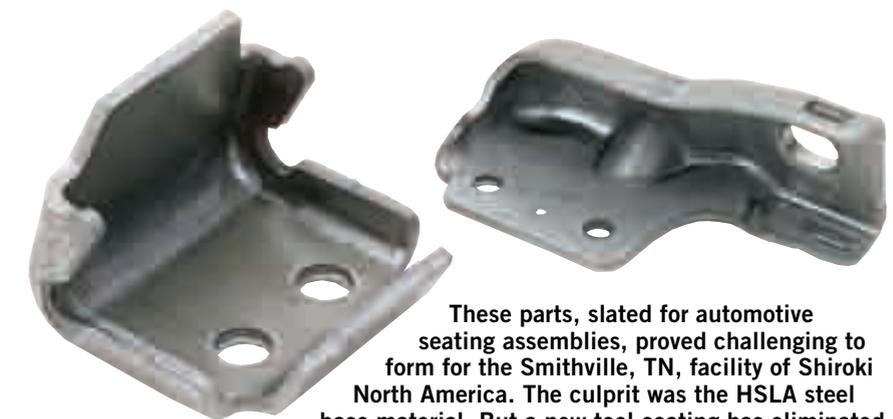
These parts, slated for automotive seating assemblies, proved challenging to form for the Smithville, TN, facility of Shiroki North America. The culprit was the HSLA steel base material. But a new tool coating has eliminated galling and cut part-rework time and expense.

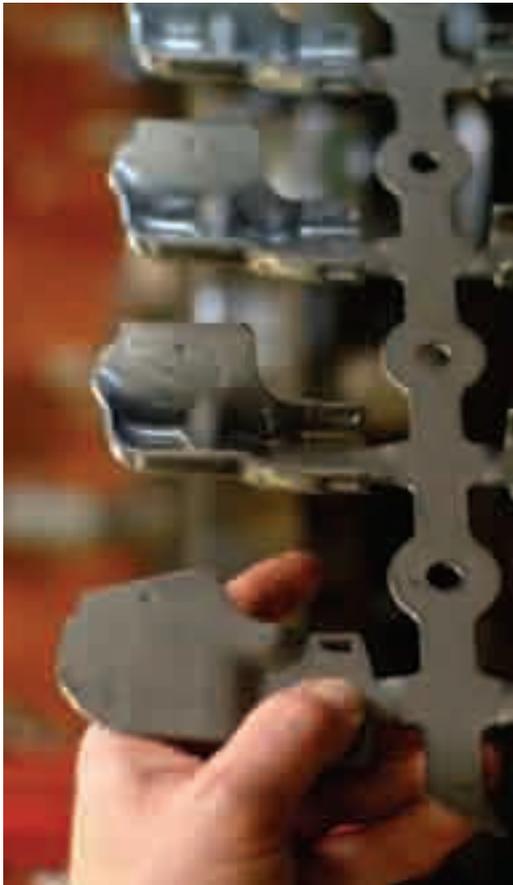
This strip progression shows the work necessary to produce the seating bracket. The stress of deep drawing this part meant frequent tool polishing. Switching lubricant provided some measure of success but a new tool coating brought much bigger benefits. For example, a prior tool coating enabled production of 12,000 to 18,000 parts when the tooling began to gall and Shiroki North America had to rework the parts. But in the six-month period after the company began using a new coating, the tooling has produced about 120,000 pieces with the coating still in good condition and no need for part rework.

good job but didn't hold up to expectations," Dunkley says. "We'd start out with the new coated tooling and the first one or two runs we'd hardly have any issues. But then, after two or three runs, we started to see galling and had to go back to inspecting parts as before. We're talking about 6000 parts per run, so after running 12,000 to 18,000 parts with the TD coating, the tooling began to gall and we had to resume reworking the parts."

"I had the forms coated and let the toolmakers in the toolroom tell me if it was a success," Dunkley recalls. "Our tooling people have been very impressed with the coating—it took a lot of pressure off of them. We had the form coated in mid-2006, and haven't replaced the form yet. Now, when we finish a run and send the tooling to the toolroom, we don't even have to polish it. We just wipe it off and send it back to the pressroom. During the six-month period since we've had it coated, the tooling has produced about 120,000 pieces. The coating is still in good condition and we have not had to do any rework on the brackets produced with those coated dies."
